The Effect of Pipe Expansion on Fusion Bonded Epoxy Coatings

**Energy Pipeline Industry
Pipe Quality Action Plan
November 5, 2010**

**The INGAA Foundation
2010**

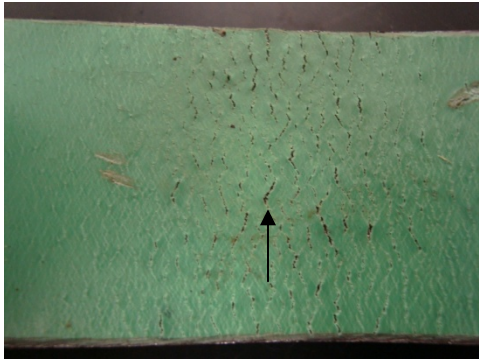
Figure 4

The testing stopped when cracks were observed visually in the coating. Holidays in the coating were verified by a wet sponge jeep set at 67.5 volts. Examples of the types of cracking seen are shown in Figures 4 and 5.

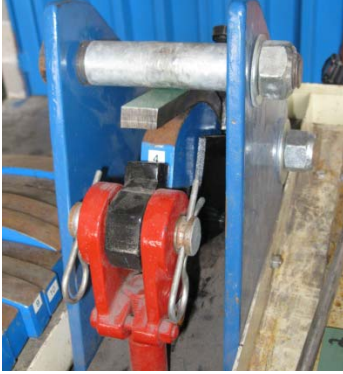
Figure 7

We found that a four inch radius mandrel creates signs of stress in the coating, will generate permanent strain levels between 7.3°/PD and 7.6°/PD total strain depending on strap thickness (Figures 7 and 8).

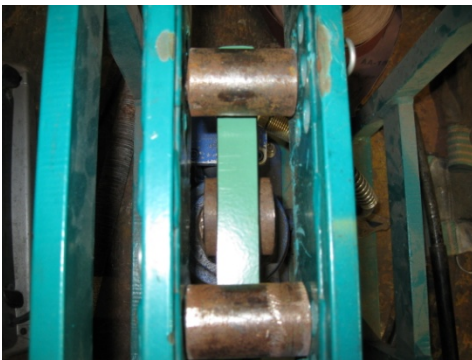
Figure 9

When attempting to create a crack in the coating using the four-point bend method, the strap had to be bent almost 180° before cracking was observed. While creating this failure mode it, should be noted that the time it takes to complete the bend is important; too fast a bend rate can result in disbondment of the coating in the area of the bend. For this experiment, the bend was completed in a 20 to 30 second time frame. Due to the extreme degree of bend required to show cracking a mandrel was made from a piece of 1 in. radius bar stock (Figure 6). This resulted in permanent strain levels between 27.17°/PD and 27.82°/PD total deflection. A wet sponge holiday detector was used to determine the presence of holidays; refer to Figures 9 and 10.

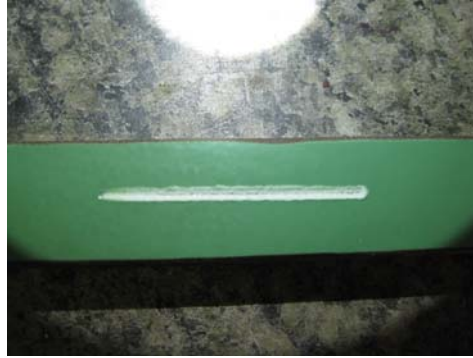
Figure 11

While completing the bend tests, the impact of damage to the coating, such as a gouge (Figure 11), were also studied. It was found that a gouge in the coating, that did not penetrate through the coating, could create a stress riser for a coating crack to initiate and propagate when put under strain. This effect of the stress riser was

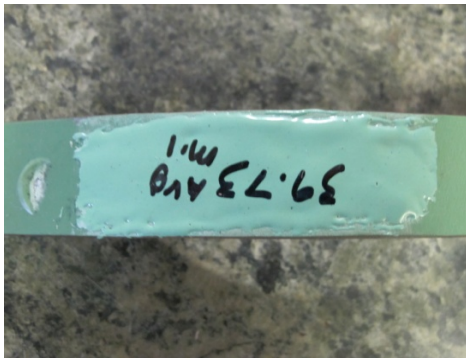
Figure 12

reduced by applying a two-part liquid repair epoxy to the damaged area prior to bending. In this instance initially the repair material showed no signs of cracking (Figure 12) when bent with the 1-inch radius mandrel, however, after resting for a one week period cracks and holidays (Figure 13) did appear in the coating.

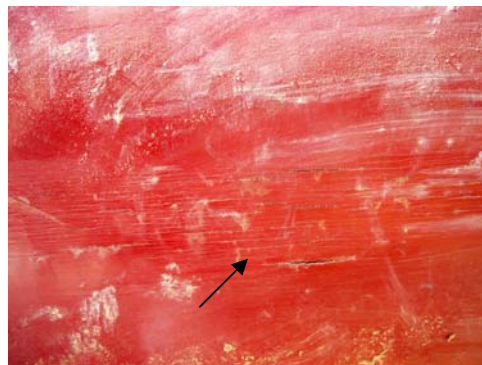
Figure 16

Stress marks and cracking were observed over approximately half of a pipe joint at one location that measured 3.06% expansion (permanent strain), Figure 16. The coating showed good adhesion as reflected by a cross-hatch test. Holidays were identified and after visual inspection, were verified as shovel dings and damage from probing made during initial excavation.

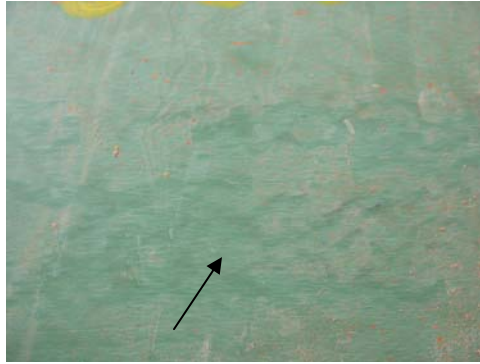
Figure 17

Signs of initial stress (stress marks) Figure 17, in the coating were observed at two localized expansions on the pipe. A picture was taken at the location of largest expansion, which was 1.73% (permanent strain).

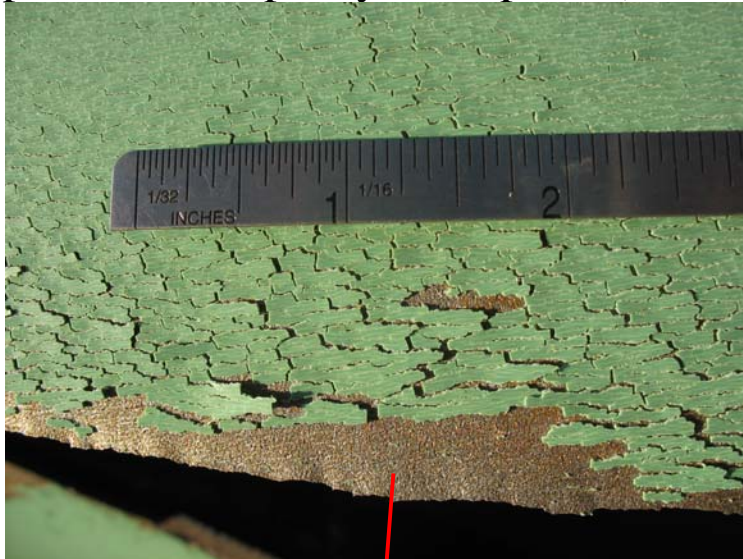
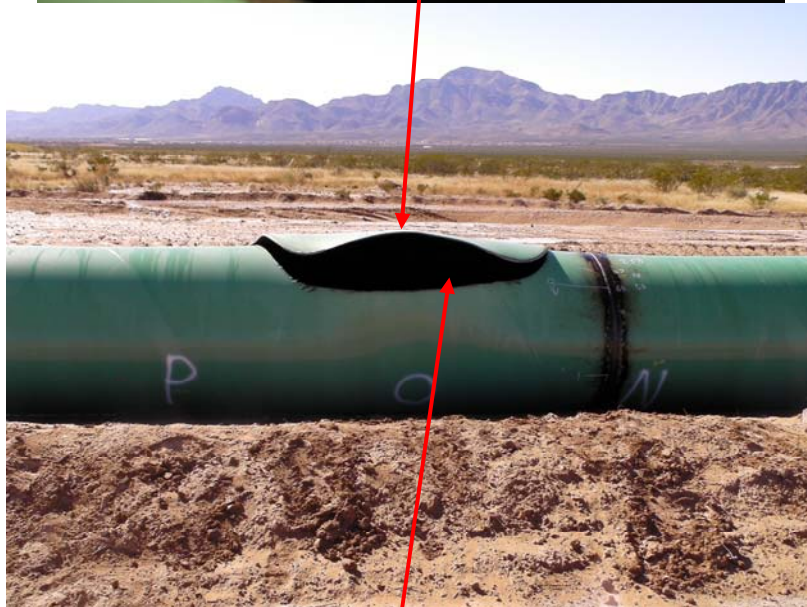
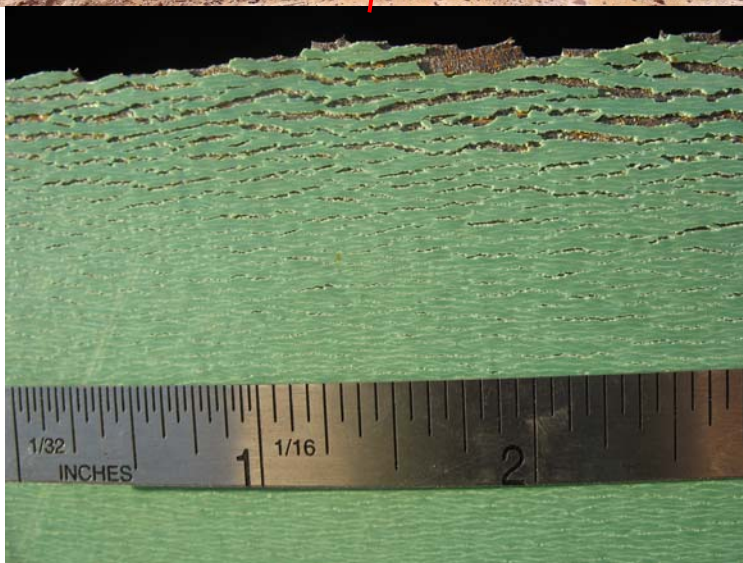
Valspar Coated Pipe Hydro-rupture (P1, P2, P3)

The above image of the Valspar coated pipe after hydro rupture. The red markers indicate where along the fracture site images were taken. The torn coating took on a “puzzle piece” type morphology which appeared to flow parallel to the micro-cracking on the pipe body.

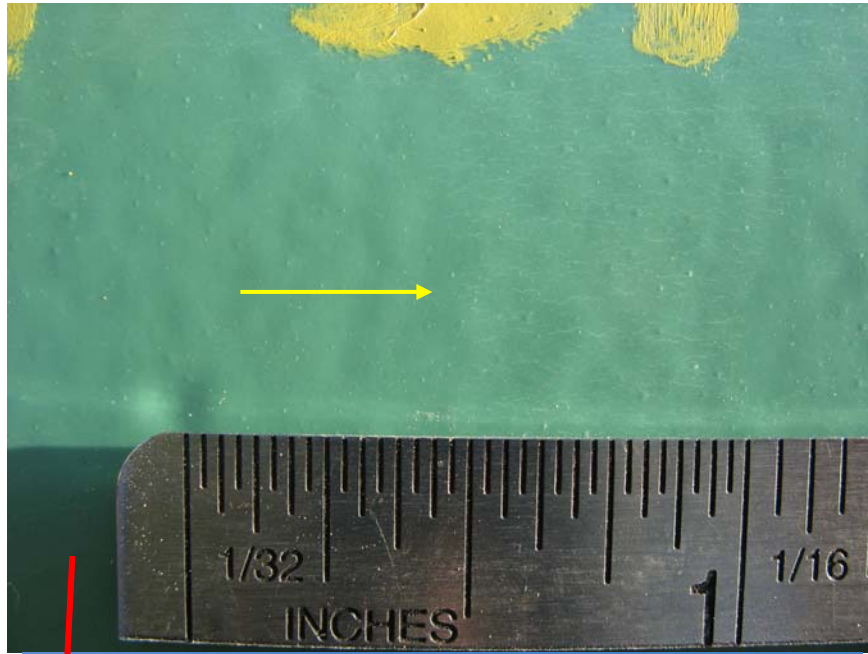
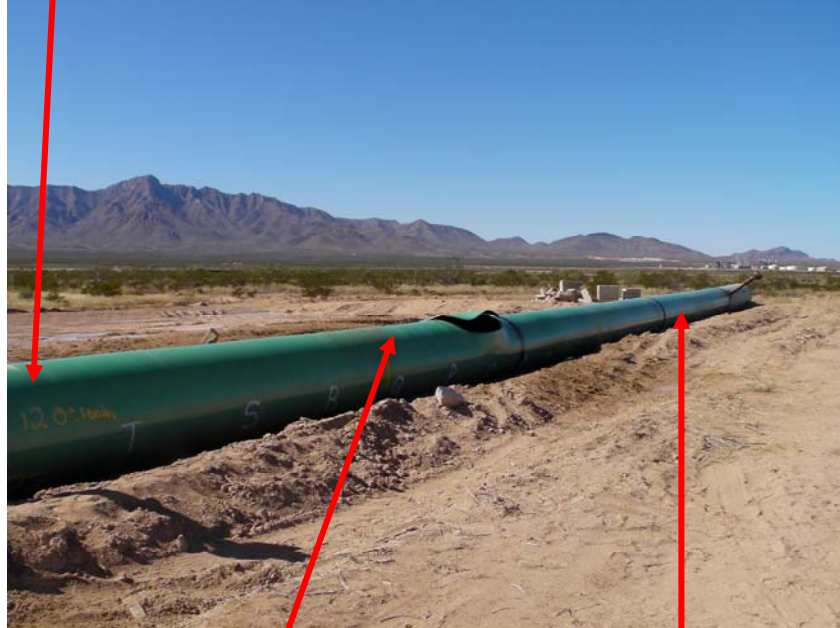
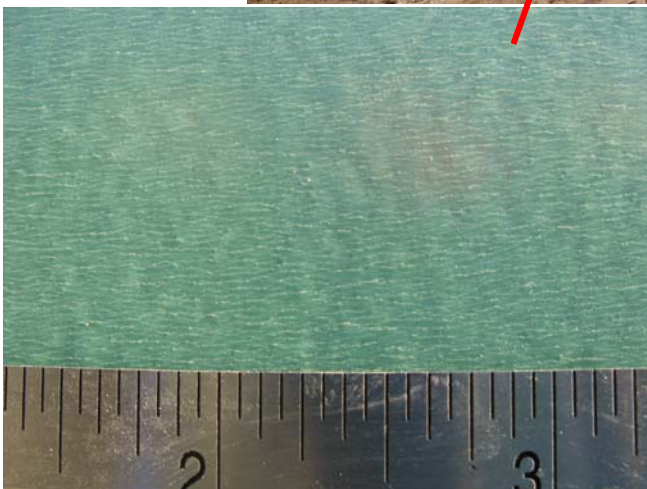
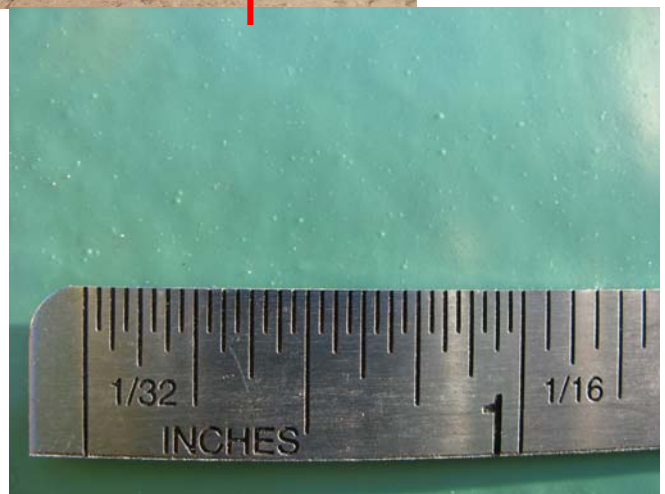
The above images of the micro-cracks observed on the coating pipe body illustrated by the red and yellow markers. The micro-cracks extended approximately 40ft. upstream and downstream of the rupture site, after which undamaged pipe coating was visually observed.

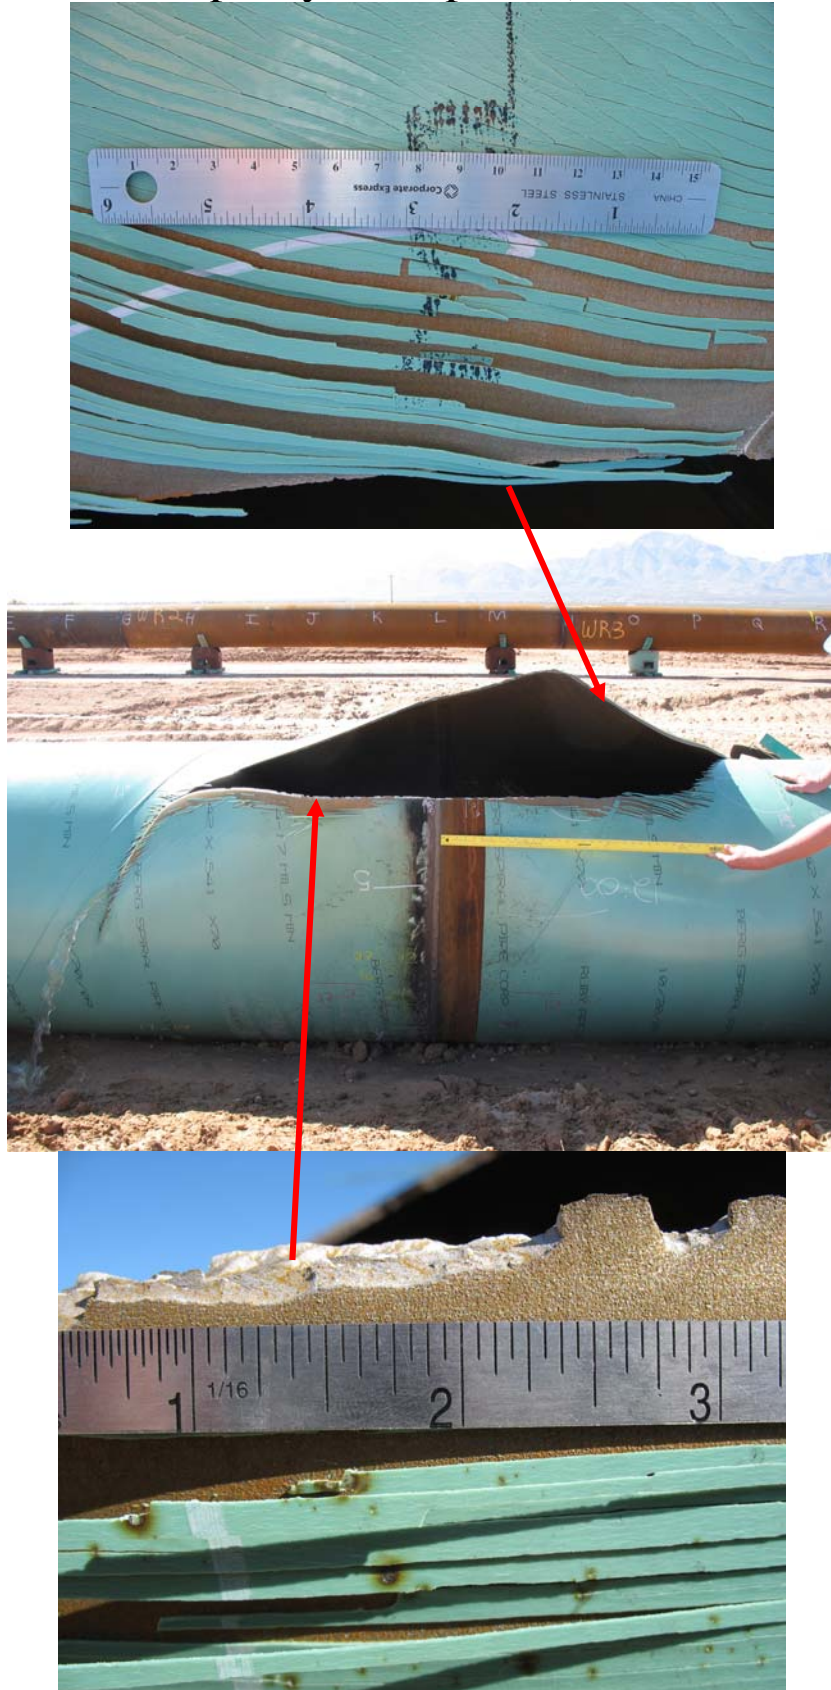
3M Coated Pipe Hydro-rupture (BC1, BC2, BC3)

The above images of 3M coated pipe adjacent to the rupture site. The red markers illustrate the location on the pipe where the images were taken. The torn coating took on a strip type morphology which ran parallel to the direction of the micro-cracks observed on the failed pipe.

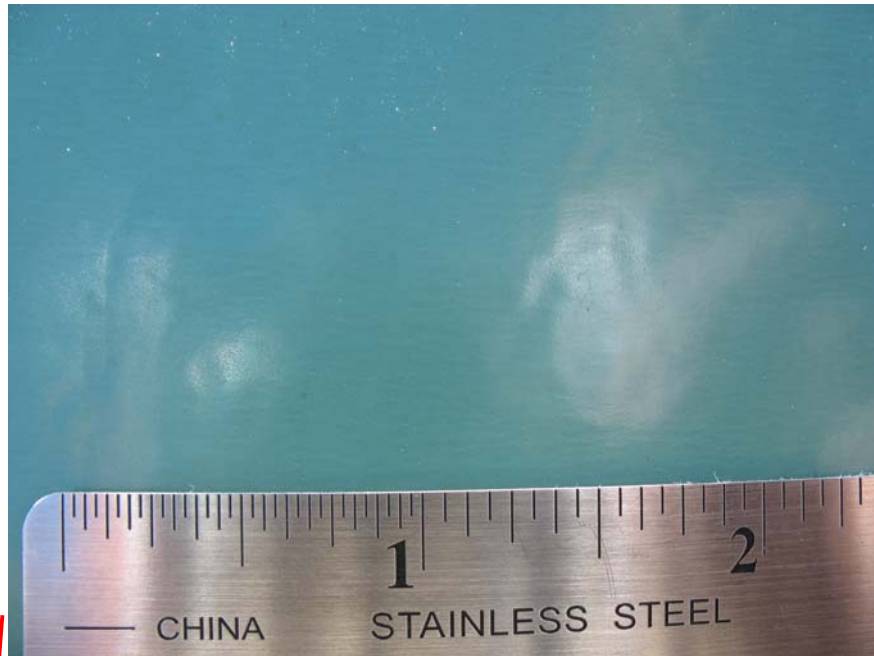
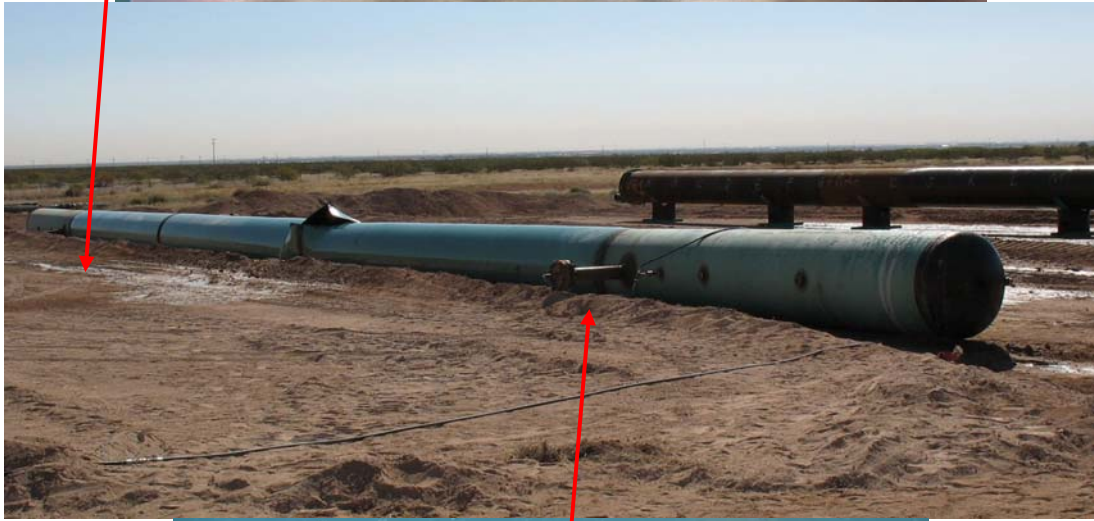
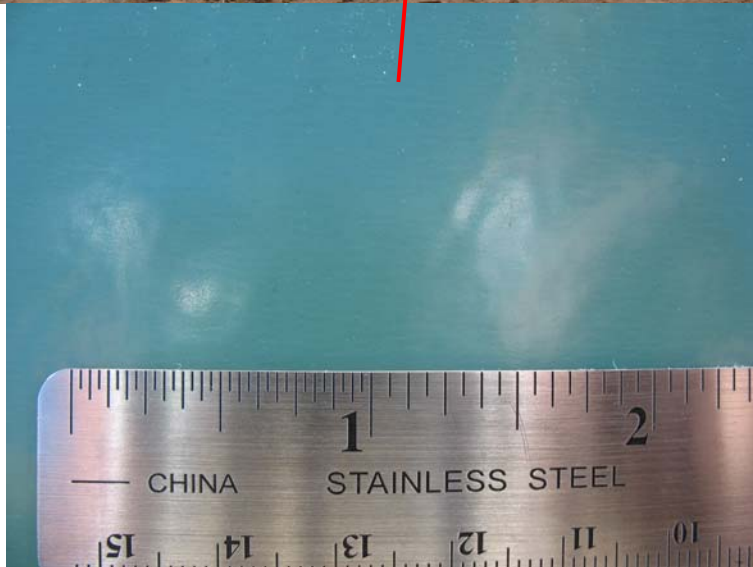
The above images of the micro-cracks observed on the coated pipe body illustrated by the red markers. The 3M coated pipe displayed micro-cracks through the entire pipe body, the cracks ran axially along the pipe. Regions adjacent to the end cap girth welds did not display the observed micro-cracking due to the increase strength and thickness of the end caps.
